# Failure phenomena and countermeasures for tunnelling in heavily squeezing mudstone

Y. Nakamura\*, M. Hada\*, H. Sakai\*\*, Y. Miyagawa\*\*, E. Kawakami\*\*, T. Nagai\*\*

The Nikkureyama Tunnel, which is 2,223m long, is part of the Joshinetsu Expressway which links Tokyo and Niigata in Japan (Fig. 1). It is a twin road tunnel with a diameter of 11m. The geology of the site mainly consists of Andesite. However, in the vicinity of the middle part of the tunnel, there was a squeezing mudstone section. In this section, the tunnel suffered from considerable crown settlement, invert settlement and convergence. The maximum initial rate of convergence was 50mm/day. Then failure phenomena such as breakdown of shotcrete lining, buckling of steel support with wing rib and cave-in from the tunnel face were observed (Fig. 2). Furthermore, the maximum rate of rapid water inflow was 3m<sup>3</sup>/min.

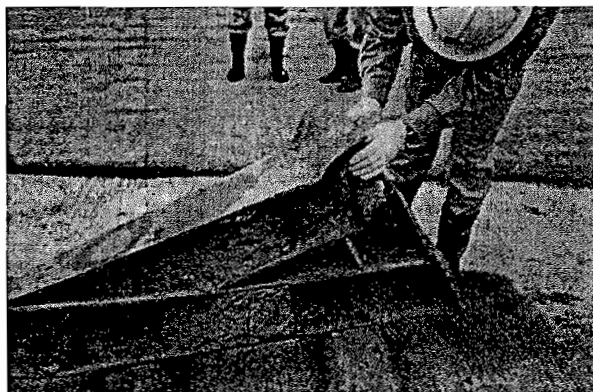
Fig. 2 – Buckling of steel support.  
Fig. 2 – Snervamento delle centine metalliche.

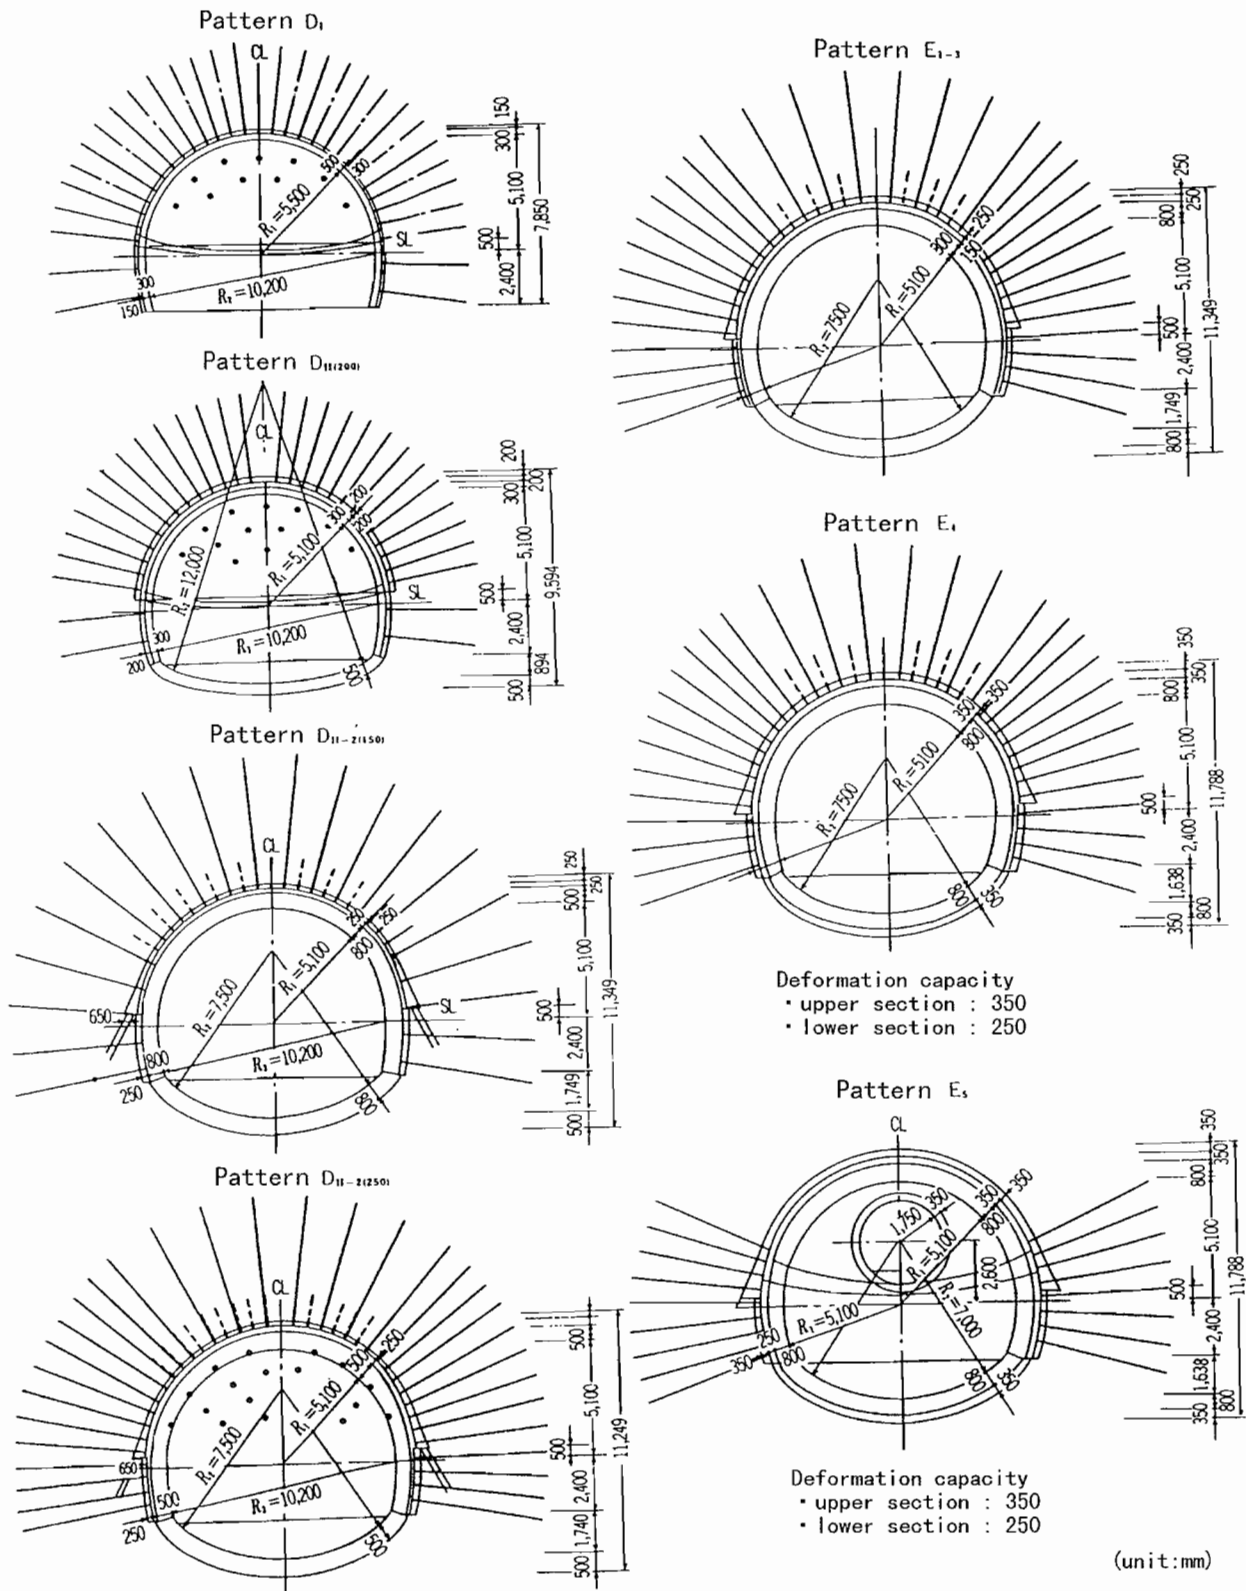
Fig. 5 - Variation of support patterns in cross section.  
 Fig. 5 - Variazione degli schemi di sostegno per le diverse sezioni tipo.

proach was applied. Various support sections were adopted on the basis of the geological characteristics and consideration of failure phenomena (Fig. 5). Especially in the section between Sta. 562 km 850 m and Sta. 564 km 050 m, it was extremely difficult to excavate the tunnel. In the case of section E<sub>4</sub>, a closed ring of reinforced concrete was formed and the stiffness of the support system con-

siderably increased by casting the invert. As a result, the rate of convergence reduced, however complete stability was not achieved. According to long lasting deformations, continuous failure phe-

nomena were observed (Fig. 6). A circular pilot tunnel was additionally required as shown in Fig. 5.

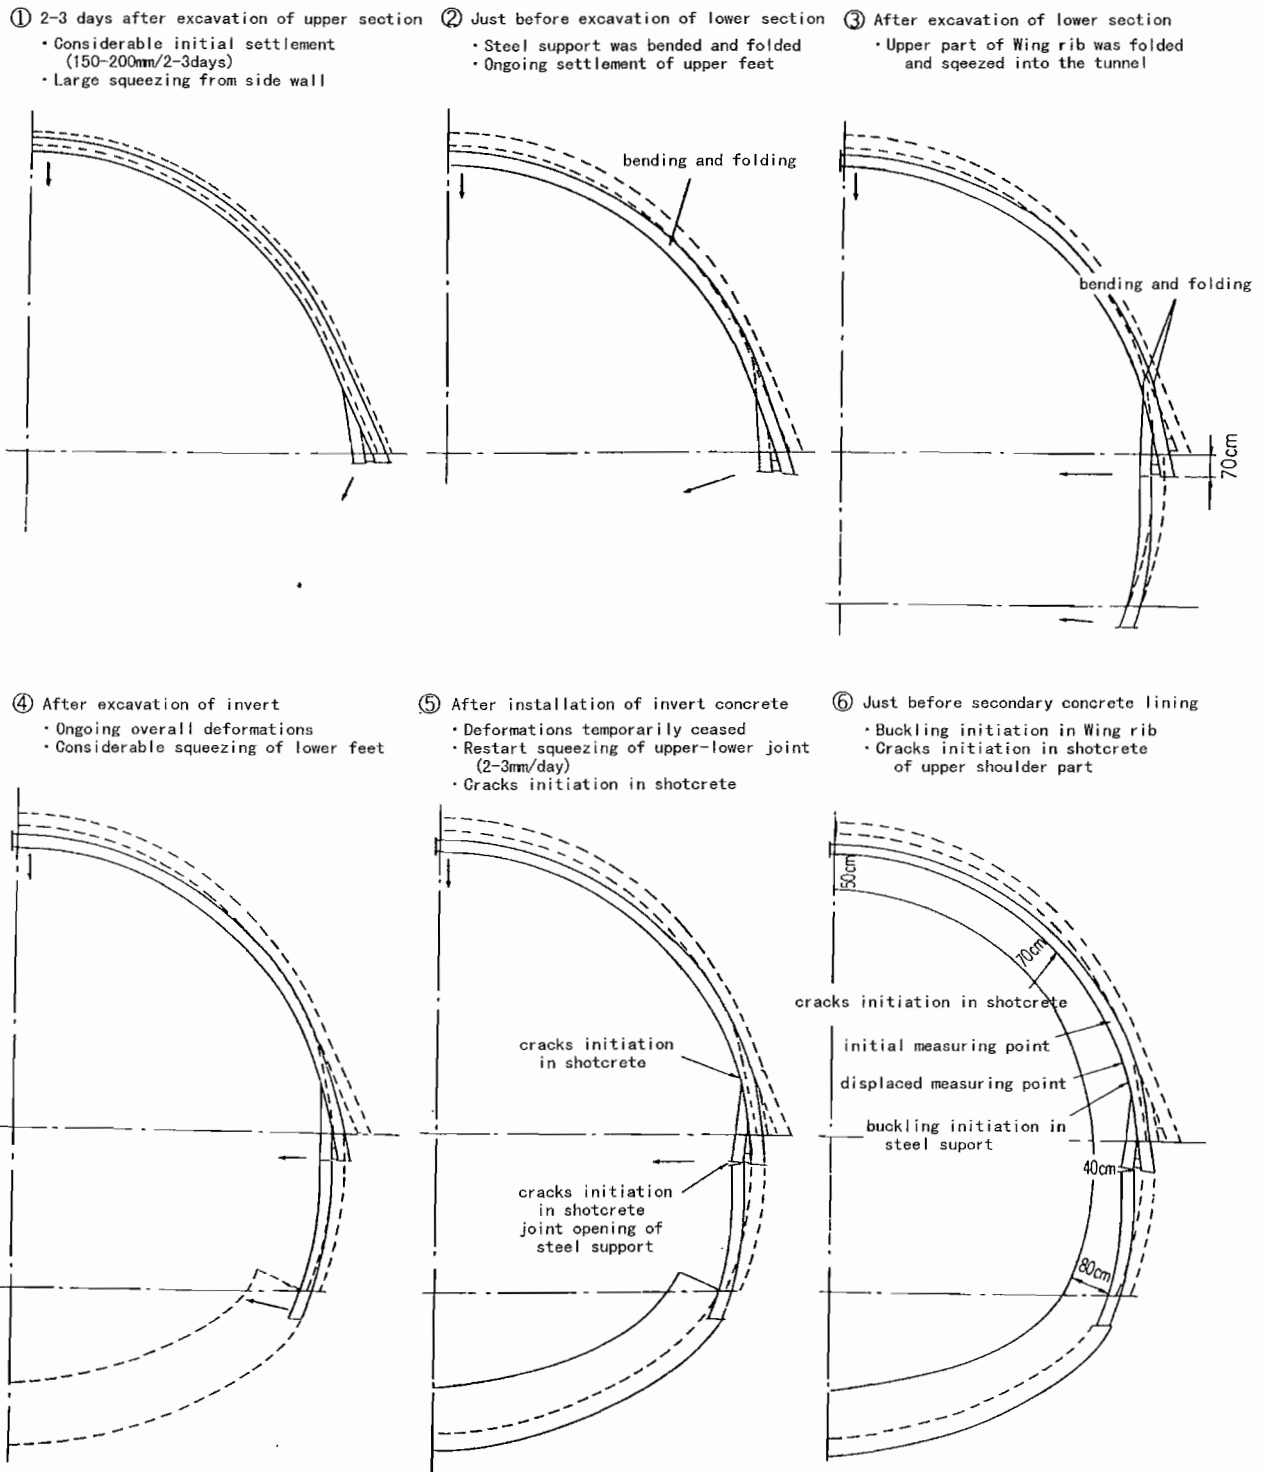
Fig. 6 - Typical ongoing failure process in relation to the construction phases.  
 Fig. 6 - Tipico fenomeno di instabilità nelle diverse fasi di scavo e costruzione.

To permit casting, even though deformations were still in progress, the pressure that would develop had to be properly evaluated in the squeezing section. In order to do this, framed structure analysis was executed based on the field measurement results. As secondary lining, SFRC (steel fiber reinforced concrete) was adopted. However, the deformations did not stabilize. Countermeasures for it were also deeply considered.
