Monitoring-driven design of a multiphase intervention for the preservation of the Frari bell tower in Venice

Guido Gottardi,* Alberto Lionello,** Michela Marchi,* Pier Paolo Rossi***

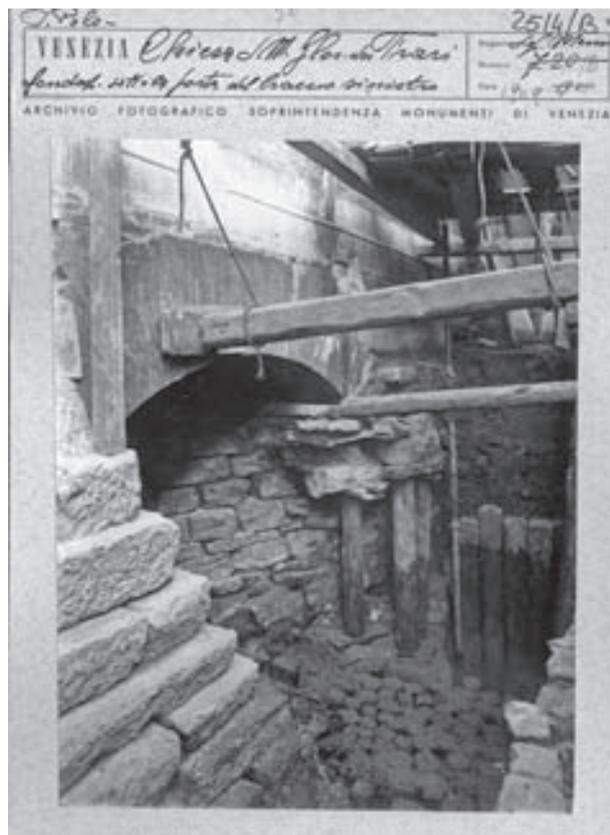
Fig. 2 – Picture of the strengthening intervention on the bell tower foundations, dated back 1904 (Photo archive of the *Soprintendenza per i beni architettonici e paesaggistici di Venezia e laguna*).

bulk of the bell tower, this being therefore the main cause of the tower settlements. For this reason, a strengthening intervention on the bell tower raft foundations was carried out, consisting of widening its base, starting from the south side (toward which the tower was essentially leaning). At the time, the intervention was designed according to the traditional Venetian soil strengthening technique [MARCHI *et al.*, 2006], with the insertion of closely spaced timber piles. The piles, 3.80 m long, 0.20 × 0.20 m of transverse dimensions and essentially touching each other, were made from larch and covered by a 2.00 m wide concrete bed, parallel to the side of the bell tower (Figs. 2 and 3). All the masonry walls were also treated with cement mortar to restore the cohesion of the brick masonry and improve its strength. Such raft foundation enlargement had been most probably designed as to be extended to the other sides; as a matter of fact, however, for emergency reasons that gave priority to other interventions, it was never completed [LIONELLO *et al.*, 2007].

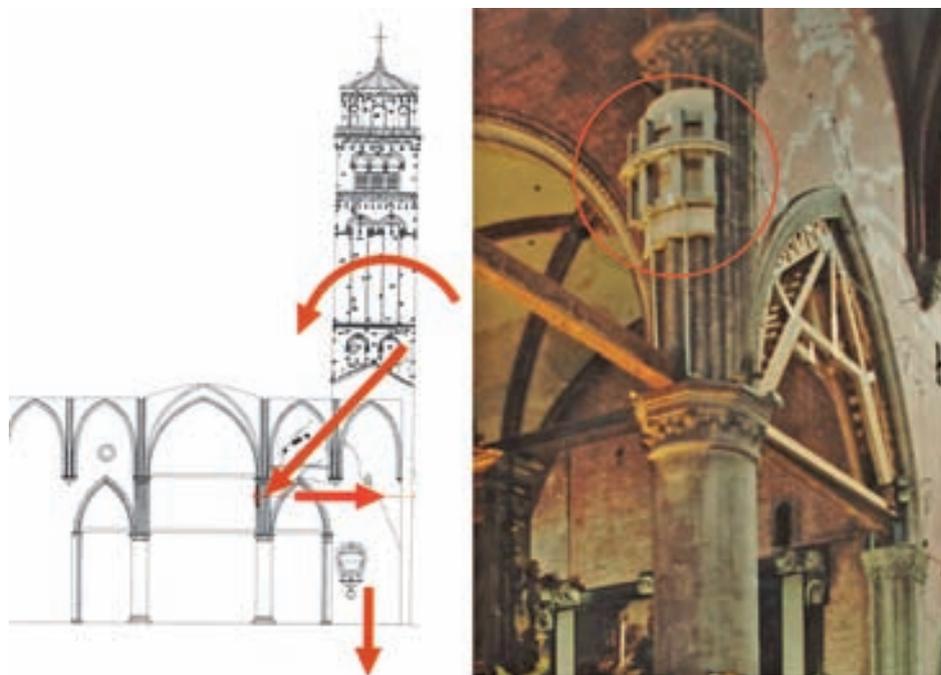
Fig. 4 – Left: possible evolution of the bell tower displacements after the bell tower foundation enlargement in 1904 and interaction with the adjacent basilica structures. Right: a picture of the temporary intervention by a steel cable to support part of the horizontal thrust acting on the adjacent column of the Frari basilica [LIONELLO *et al.*, 2004].

ble flat-jack tests on the masonry walls, sonic tests on steel ties, monitoring of the main cracks by means of extensometers and installation of clinometers for the detection of rotations of the bell tower, as well as preliminary geotechnical investigations of the foundation soil. In 2000, a further survey aimed at detecting the differential settlements of the bell tower, by comparison with 1902 situation, revealed settlements as large as 49.8 mm in the east corner, 61.3 mm in the south corner and 92.3 mm in the west corner of the bell tower base [LIONELLO *et al.*, 2004]. These findings, together with the results of the photogrammetric survey of the 1990's, indicated that the bell tower was tilting in the opposite direction with respect to the "historical" trend, essentially moving back toward its vertical position (Fig. 4). This was most probably the consequence of the 1904 foundation widening.

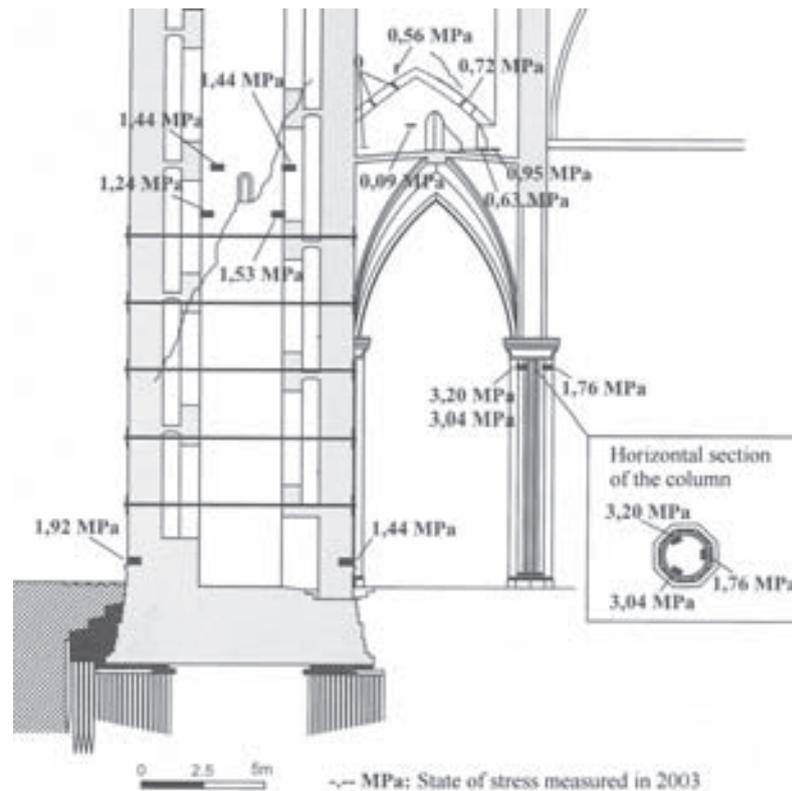
Fig. 5 – Left: values of the state of stress measured by flat-jack test in the structures of the Frari basilica and of the bell tower [LIONELLO, 2008].

Flat-jack testing technique was used to measure the existing state of stress on the masonry structures of the bell tower and of the adjacent basilica. At the base of the bell tower an average value of 1.92 MPa was measured on the outer side, while on the inner part a mean value of 1.44 MPa was estimated (Fig. 5). Inside the bell tower, flat-jack tests were carried out on both sides of an inclined oblique crack which runs along the south-west side of the tower. The similar stress values measured at two different levels, clearly show that the crack, even if passing through the entire thickness of the wall, does not induce particular stress concentration on the structure. Very high values of compressive stress were measured at the top of the column sustaining the propped arch: 1.76 MPa on the outer side and 3.20 and 3.04 MPa on the inner side (Fig. 5). A detailed analysis was also carried out on the wall above the propped vault and the results indicated the presence of a thrust line going from the bell tower to the structures of the basilica (shown in Fig. 4), in correspondence of the upper area of the above-mentioned column, with stress values ranging from 0.56 MPa to 0.95 MPa. The presence of this thrust line was also confirmed by the results of the relevant numerical model, carried out during the investigations [LIONELLO, 2008].

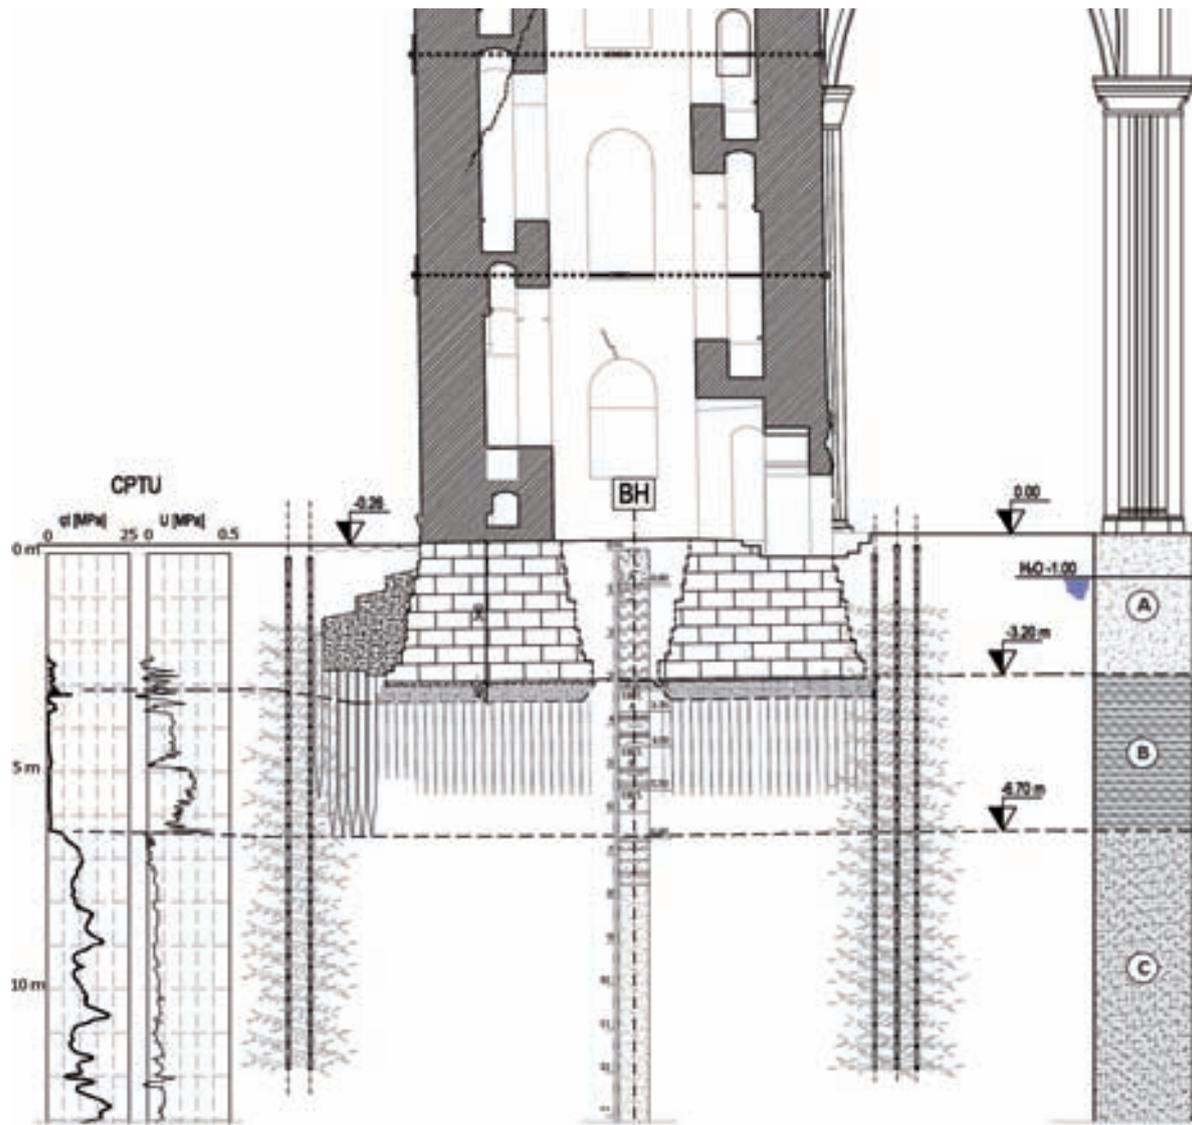
Fig. 7 – Schematic section of the tower foundation and of the relevant subsoil (SE-NW direction in Fig. 6), with the in-situ test logs, the strengthening intervention of 1904 (left) and the TAMs of the new fracture grouting intervention [GOTTARDI *et al.*, 2013].

mainly attributed to a slow lateral plastic flow under high stress gradients within the soft silty clay layer, squeezed between the pile ends and the underlying sand, and to the possible progressive decay of timber piles.

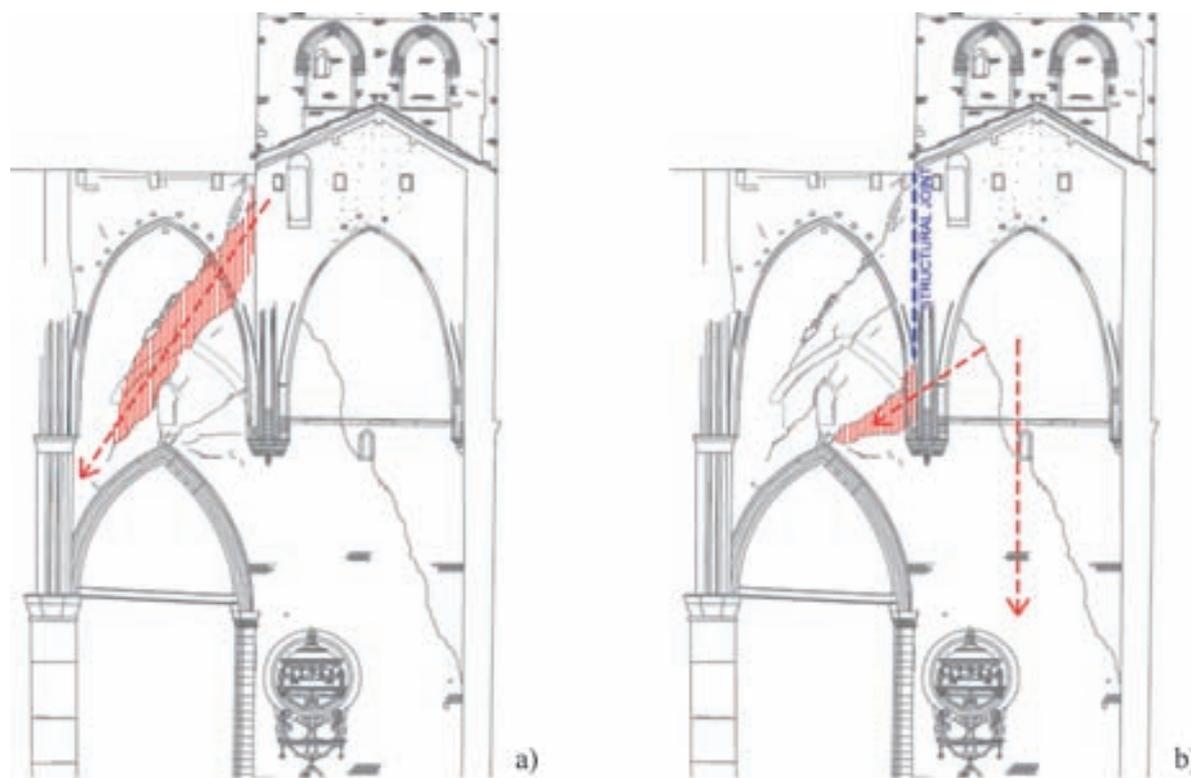
Fig. 13 – Direction of the thrust between the bell tower and the basilica: a) before the structural joint execution; b) after the structural joint execution.

According to a suitably conceived approach for the restoration and preservation intervention, it was therefore opted, instead of opposing against the current forces acting on the structures, to reduce their stress distribution [LIONELLO, 2011]. About two years after the end of strengthening works on the foundation soil, it was decided to insert a gap between the bell tower and the adjacent church by creating a structural joint that would allow the relative movements and prevent the mutual stress transmission. It was assumed that the compression stresses flowing above the arch and transmitting substantial forces to the column of the basilica (Fig. 13a) could be thus reduced.

The structural joint was created at the beginning of June 2008 in the position shown in figure 13b and, in order to preserve the basilica architecture, it was carried out only above the vaults where, on the other hand, mechanical interaction was greater. During the intervention, it could be confirmed that the existing structural link had been executed only after the construction, probably together with the early 20th century interventions, when it was wrongly pursued the approach of connecting the bell tower to the basilica structures.

The effect of such intervention was a marked change of direction of the thrust applied by the bell tower to the adjacent column, as shown in figure 13b and predicted by numerical models.

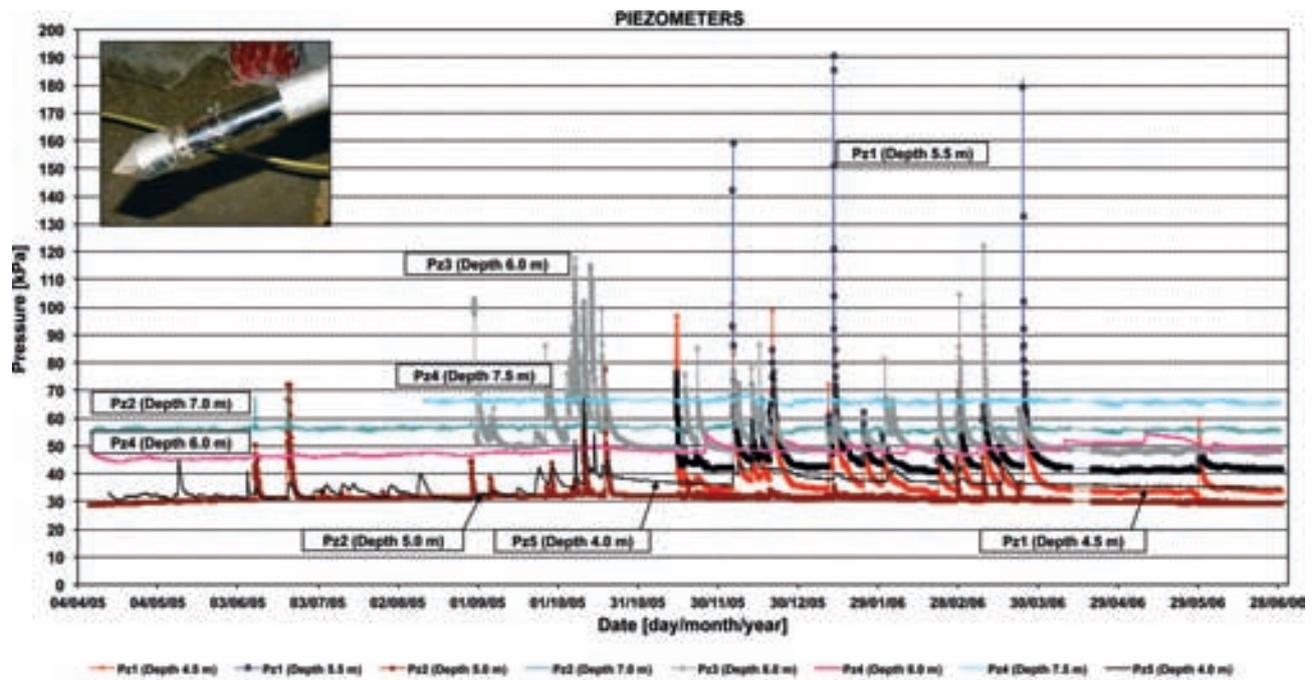
Fig. 14 – Records of most electric piezometers installed within the silty clay layer (after LIONELLO, 2008).

As reported in section 2.3, the geotechnical instrumentation installed throughout the area of the intervention enabled to carefully check the effects of the soil fracturing. As an example, in figure 14 the records of most electric piezometers installed within the silty clay layer are provided: the pore pressure peaks induced by adjacent grout injections

are clearly visible as well as the subsequent relatively quick consolidation rate, which enabled to drive the operations under constant control and safety conditions.

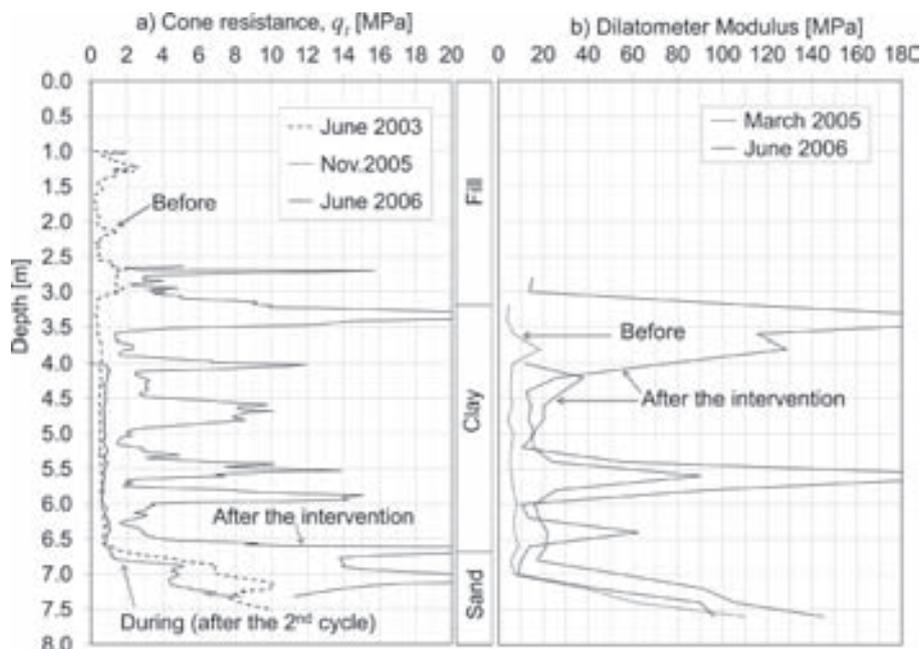
Fig. 15 – Comparison between a) CPTU cone resistance and b) dilatometer modulus before the intervention after the second injection cycle and at the end of the injections (after LIONELLO, 2008).

As designed, the injections led to soil fracturing: evident and diffuse cement lenses in the soil were found in undisturbed continuous core sampling carried out at the end of the intervention. Specific additional in situ geotechnical investigations (piezocone and dilatometer tests) were planned and carried out to assess its effect on the mechanical properties of soil. The global effect of the injections could be assessed by comparing the results of in situ tests performed at different stages of the intervention. The soil strength improvement is clearly noticeable from all the CPTU tests carried out before the intervention, after the second injection cycle, and at the end of the injections (Fig. 15a) (respectively CPTuⁿ/A, /D and /E in Fig. 6). Peaks of the tip resistance are due to the diffuse presence of grout lenses, although the relevant average increase among them was more effective. Figure 15b shows

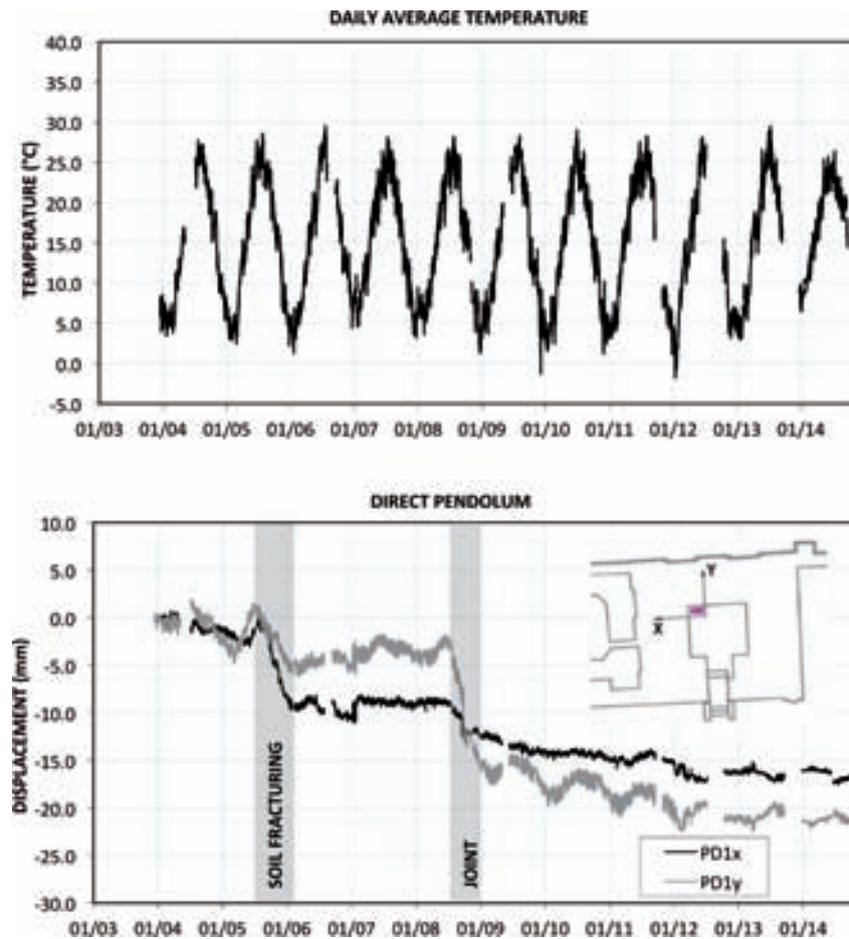
Fig. 16 – Complete history of the displacement components measured by the direct pendulum with the indication of the intervention phases: soil fracturing and structural joint execution (to 27/10/2014).

However, more comprehensive information for the analysis of the structure behaviour during the soil fracturing works come from the direct pendulum records and precision leveling surveys. In figure 16, the movement trend along two orthogonal components from direct pendulum are shown. The period of observation is from December 2003 (date of installation of the monitoring system) to the end of October 2014. During the soil fracturing intervention (from April 2005 to March 2006, grey shadow), the monitoring system was also useful to define the rate of the intervention phases as well as to support decisions on the parameters of the grouting procedures (injection pressure, flow rate, etc.). A signifi-

cant movement of the bell tower during this intervention phase was observed, the component in x direction (toward the apse) being about 9.0 mm and in y direction (toward the basilica) about 5.0 mm. After the end of the soil fracturing, the rate of the bell tower movements showed a quick reduction, reaching a lower value than that observed before the intervention. Movements of cracks in the stone arch which connects the bell tower to the basilica also showed a marked increase during soil fracturing and a rapid decrease after.

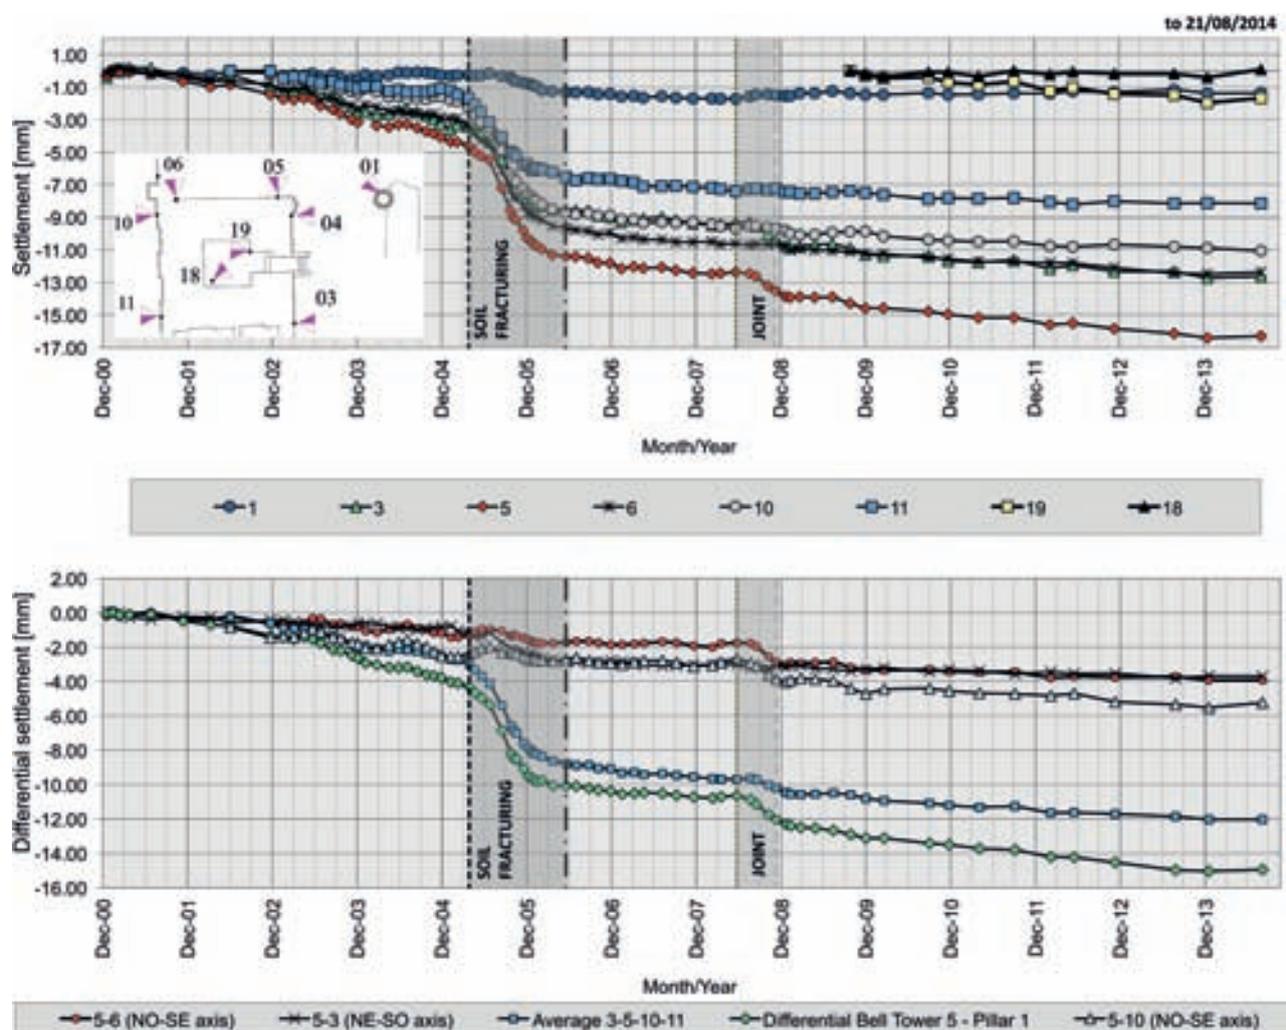
Fig. 17 – Settlements (top) and differential settlements (bottom) of several benchmarks from precision leveling (courtesy of FOART srl, Parma), to 21/08/2014.

In figure 17 the settlement trend of several benchmarks from precision leveling is provided. A more pronounced vertical movement of the bell tower west and south corners (points 5 and 6) is clearly observed during the soil fracturing intervention (time interval highlighted in grey), but all measuring points display a similar rate increase during the intervention and a significant reduction immediately after,

It is finally extremely interesting to compare the average foundation settlement during the 5 years after the joint execution with the readings of two adjacent benchmarks (18 and 19 in Fig. 17) located inside the bell tower, one at the foundation level (+1.00) (benchmark 19) and the other – more recently installed – anchored in the soil, at -6.00 m depth, just below the tip of timber piles

(benchmark 18). Despite some scatter of the readings, due to the position of the benchmarks inside the bell tower, such comparison suggests that a large part of the continuous soil straining (about 80-90% of the overall foundation settlement) occurs in the first 6 m of depth. This evidence would confirm that the progressive and already established (rather unexpected in these terms, though) decay of timber piles can count for most residual movements of the bell tower.

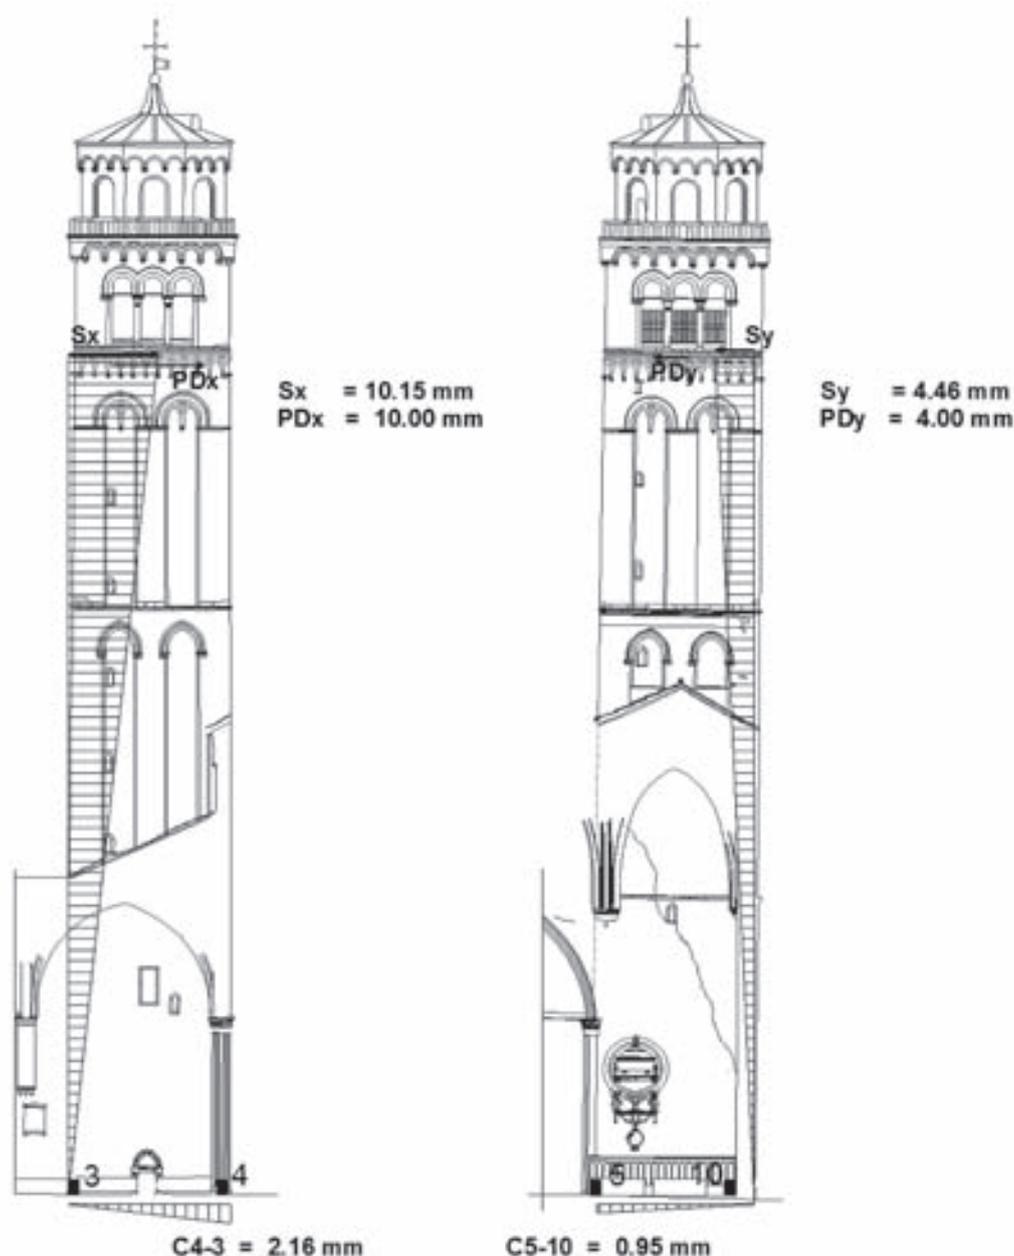
Fig. 18 – Comparison between the movements at the top of the Frari bell tower induced by the differential settlements of the foundations and those measured by the direct pendulum, in the period from December 2003 to March 2007 [Rossi and Rossi, 2012].

The settlement values are also in very good agreement with the measures obtained by the direct pendulum in the period from December 2003 to March 2007 (Fig. 18). Along the alignment of points 3 and 4, the differential settlements at the base of the bell tower (2.16 mm) multiplied for the ratio between the height and the base of the tower (4.70) turns out to be 10.15 mm, very close to the x component measured by the direct pendulum (10.00 mm). Along the alignment of points

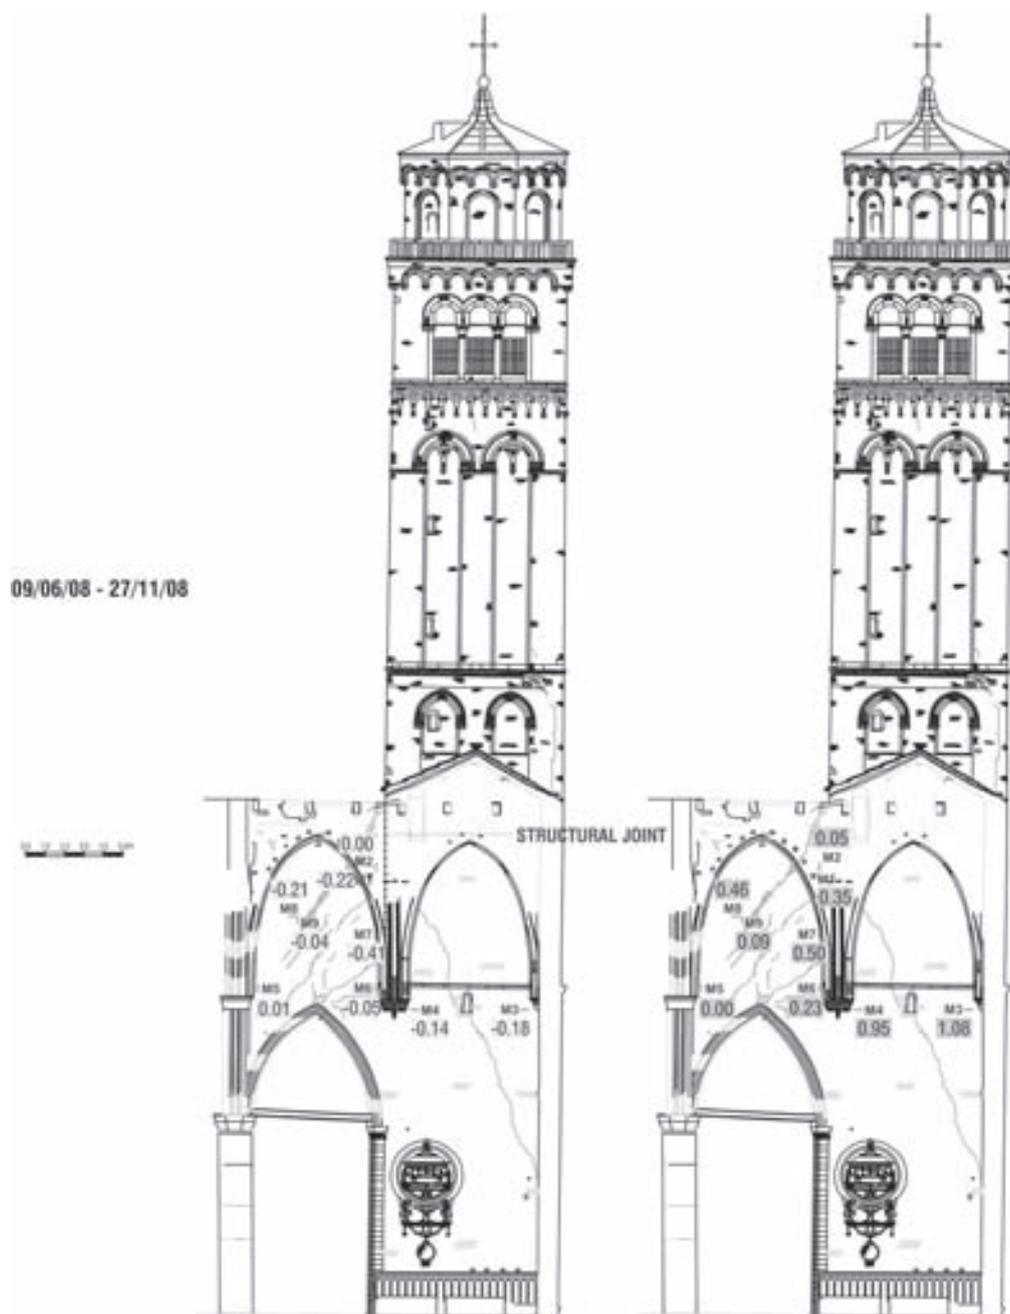
Fig. 19 – Measurements of the state of stress before the structural joint execution (on the right) and variations of the state of stress induced by the structural joint execution (on the left) [Rossi and Rossi, 2012].

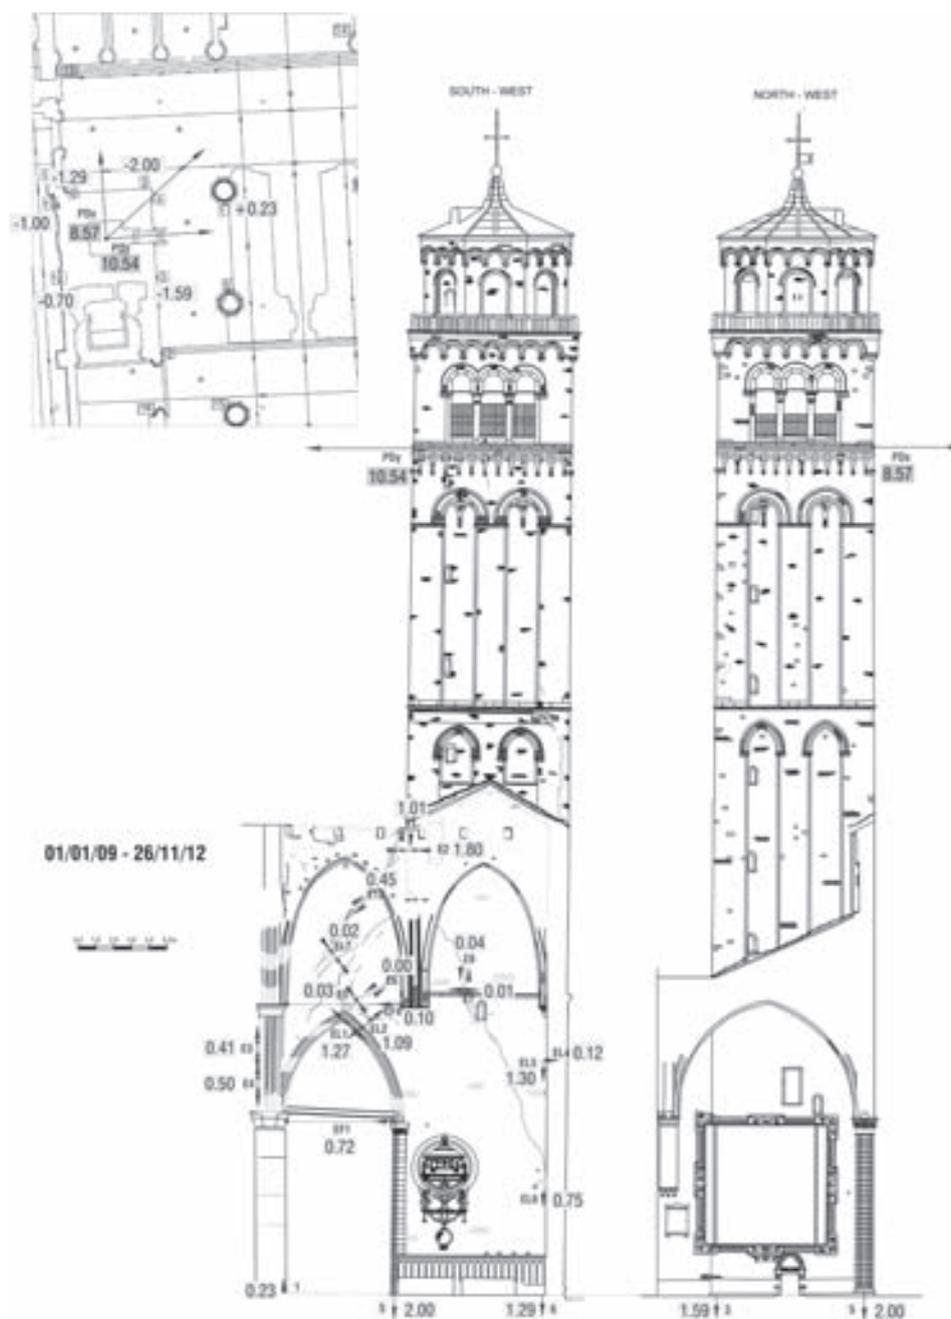
Fig. 21 – Analysis of the deformations measured during a period of about four years, after the structural joint execution.

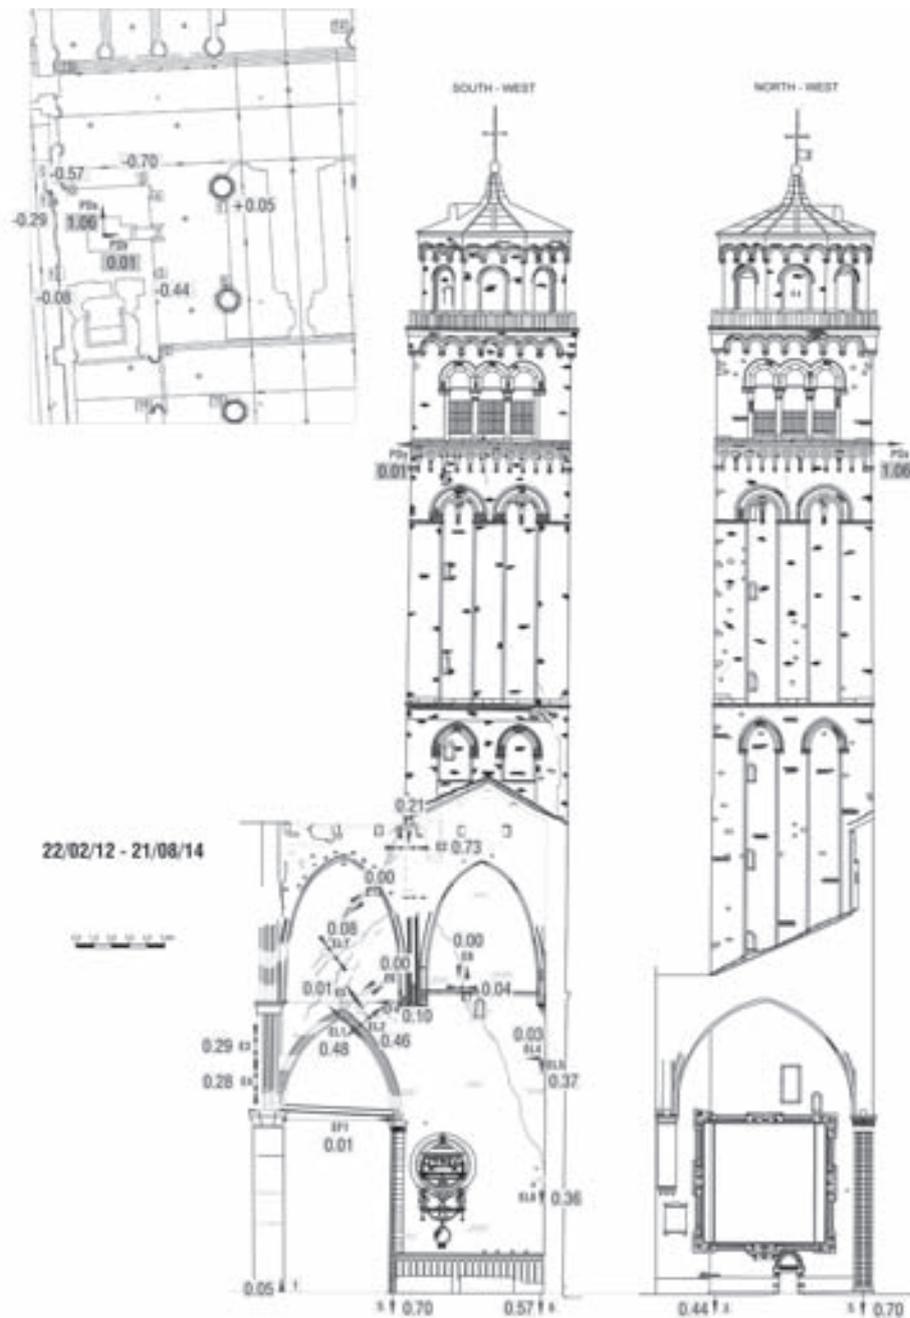
Fig. 22 – Analysis of the deformations and displacements measured in the last two years and an half.

2014). When compared to the rate of more than 1 mm/year before the soil fracturing intervention, it appears that its overall effectiveness can be confirmed.
