# Failure phenomena and countermeasures for tunnelling in heavily squeezing mudstone

Y. Nakamura\*, M. Hada\*, H. Sakai\*\*, Y. Miyagawa\*\*, E. Kawakami\*\*, T. Nagai\*\*

The Nikkureyama Tunnel, which is 2,223m long, is part of the Joshinetsu Expressway which links Tokyo and Niigata in Japan (Fig. 1). It is a twin road tunnel with a diameter of 11m. The geology of the site mainly consists of Andesite. However, in the vicinity of the middle part of the tunnel, there was a squeezing mudstone section. In this section, the tunnel suffered from considerable crown settlement, invert settlement and convergence. The maximum initial rate of convergence was 50mm/day. Then failure phenomena such as breakdown of shotcrete lining, buckling of steel support with wing rib and cave-in from the tunnel face were observed (Fig. 2). Furthermore, the maximum rate of rapid water inflow was 3m<sup>3</sup>/min.

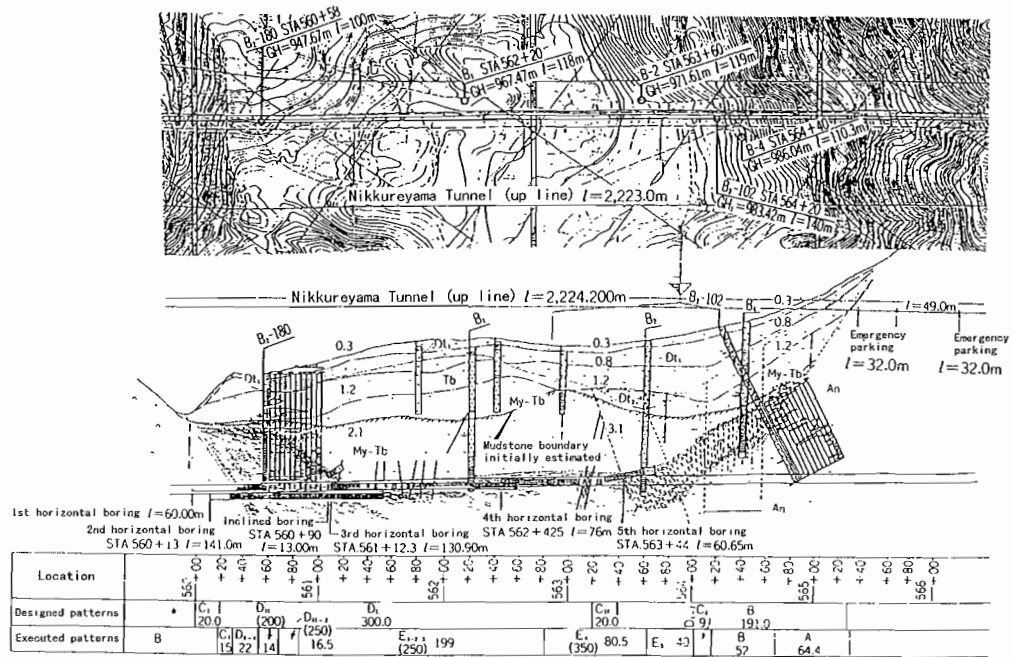
Considerable deformations and serious failure phenomena were seen to occur during excavation in the mudstone section. Ongoing investigation using vertical and horizontal borings was additionally carried out (Fig. 3). Expandability index of mudstone was quite high and a large amount of water inflow suddenly occurred several times. As a result, chemical grouting and reexcavation etc. were often forced to be executed. Finally, 34 months were required to excavate this section (Fig. 4).

Fig. 3 – Geological conditions of Nikkureyama Tunnel.  
Fig. 3 – Condizioni geologiche del Nikkureyama Tunnel.

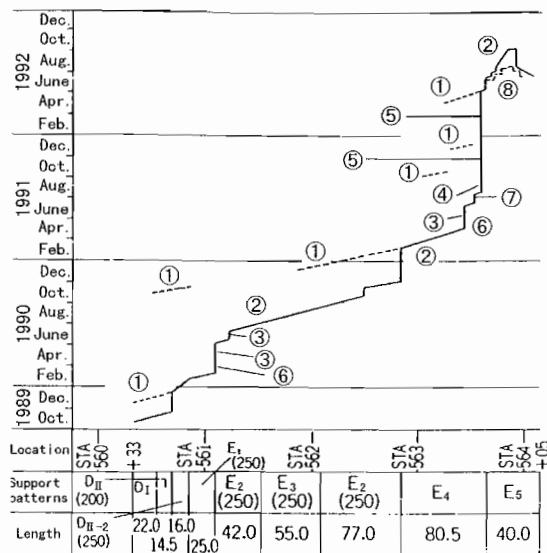
Fig. 4 – Actual progress of execution works in the mudstone section.

- ① Reexcavation,      ② Excavation of upper section,
  - ③ Grouting (LW),    ④ Grouting (SR,LW),
  - ⑤ Grouting (ES),    ⑥ Investigation boring,
  - ⑦ RJFP,              ⑧ Pilot tunnelling.
- Fig. 4 – sequenza dei lavori nel tratto in argillite.
- ① Nuovo scavo,      ② Scavo della calotta,
  - ③ Iniezioni (LW),    ④ Iniezioni (SR,LW),
  - ⑤ Iniezioni (ES),    ⑥ Fori esplorativi,
  - ⑦ RJFP,              ⑧ Tunnel pilota.
