Monitoring-driven design of a multiphase intervention for the preservation of the Frari bell tower in Venice

Guido Gottardi,* Alberto Lionello,** Michela Marchi,* Pier Paolo Rossi***

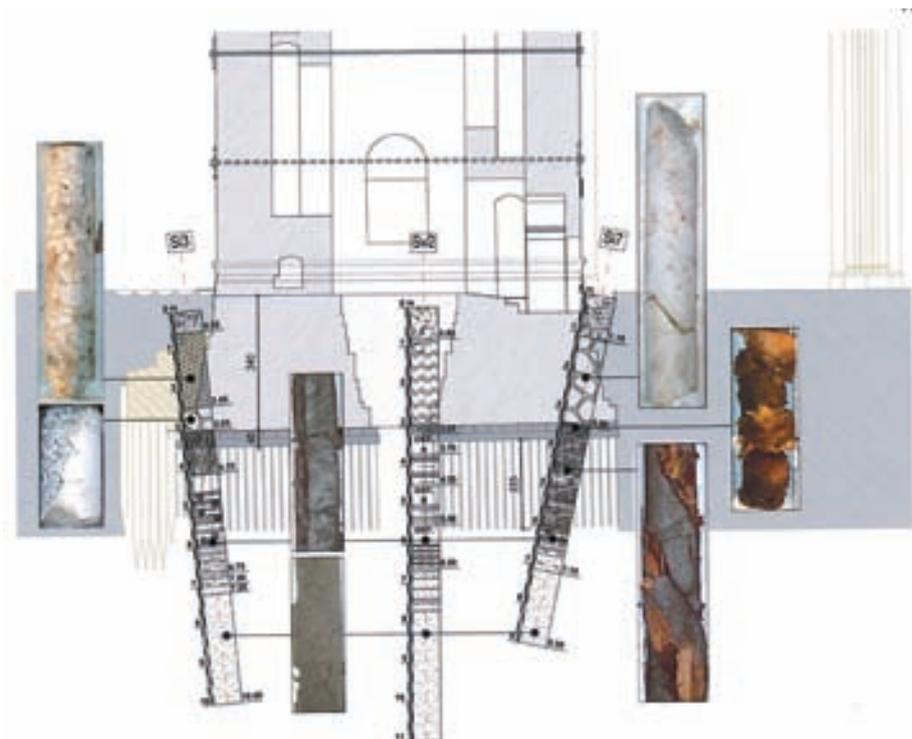
Fig. 3 – Schematic drawing of the foundation with the foundation enlargement of the 1904 on the left and pictures of samples extracted during the recent site investigation [LIONELLO, 2008].

Finally, the good conditions of the foundation enlargement built on the external side of the bell tower were confirmed. A careful evaluation of settlement trend with time excluded that the movements of the tower could be entirely ascribed to secondary settlements in confined conditions. Hence, the reasons of the continuous foundation problems were

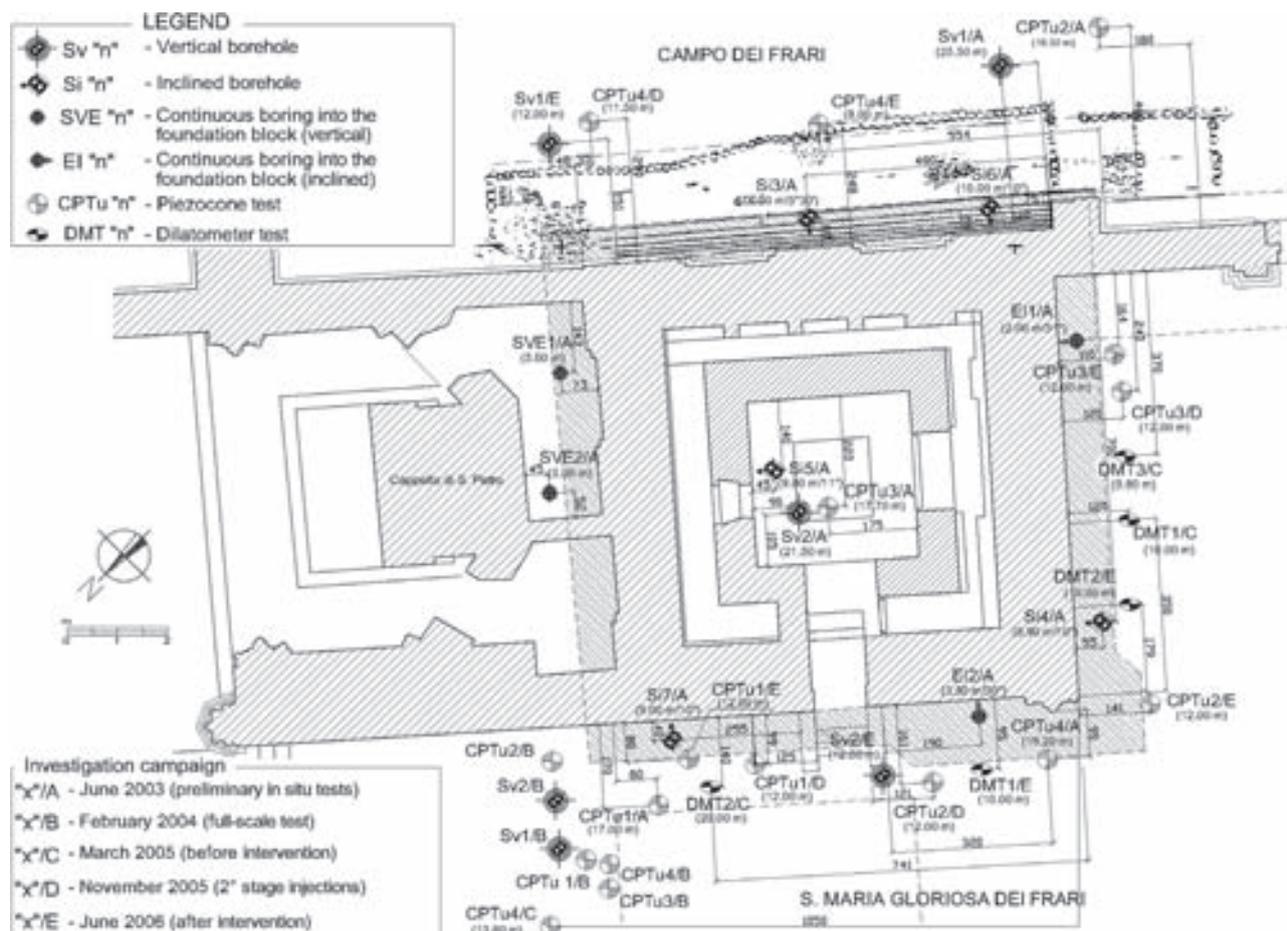
Fig. 6 – Plan of the Frari bell tower with the location of the geotechnical in-situ investigations at various stages of the intervention [GOTTARDI *et al.*, 2013].

A rather detailed geotechnical investigation was carried out in May 2003 (tests "x"/A in Fig. 6) and, on that basis, the subsequent ground improvement intervention by soil fracturing was planned. The investigations of such A-phase consisted of: 4 piezocone tests, 2 vertical and 5 inclined continuous coring boreholes, 4 continuous borings into the foundation block, together with the extraction of several undisturbed soil and foundation block samples for the subsequent execution of the laboratory tests, which enabled the stratigraphy, the subsoil properties and the geometry of the foundation block to be defined with some detail [GOTTARDI *et al.*, 2009]. A section of the thus reconstructed peculiar bell tower foundation along the SE-NW direction is provided in figures 3 and 7. As usual in Venice [MARCHI *et al.*, 2006], the Frari bell tower foundation is made up of Istrian limestone squared blocks and short timber compaction piles (1.702.20 m long), with an interposed 0.40-0.50 m thick larch boarding.

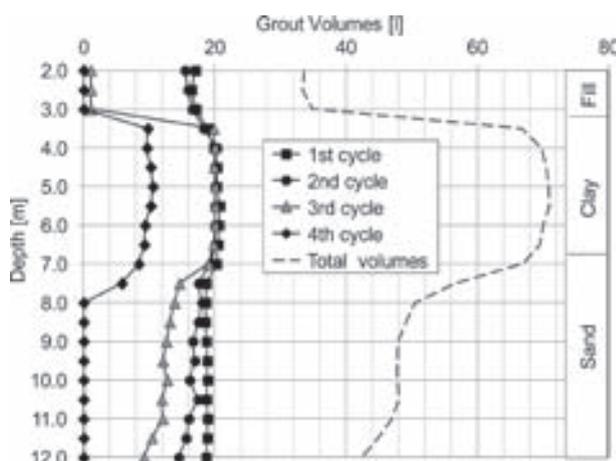
Fig. 11 – Average (for the overall 88 pipes) volumes injected from each valve, at selected depths, for the 1st, 2nd, 3rd and 4th cycle [MARCHI *et al.*, 2014].

During the intervention the flow rate was kept low and fixed at about 6 l/min. The resulting valve opening pressure and the following steady-state injection pressure were always recorded. In the final cycle, a flow rate of about half than the previous cycles was used. Relevant injected volumes are shown in figure 11. Constant grout volumes of 20 l/valve were injected each cycle in clay, whereas variable volumes between 14 and 20 l/valve in sand. In the 1st cycle all valves could be opened. In the 2nd cycle a few valves could not be opened in sand. In the 3rd and 4th cycles more restrictive criteria were adopted: a pre-fixed limit to the opening pressure of 500 kPa in clay and of 2500 kPa in sand, where therefore many more valves could not be opened. Figure 11 shows the total volumes injected in each cycle from each valve depth, divided by the total number of existing pipes (*i.e.* 88). Notice that the total amount of grout injected in clay is clearly greater than in sand. At the end of the intervention, a total of about 100 m³ of grout was injected.

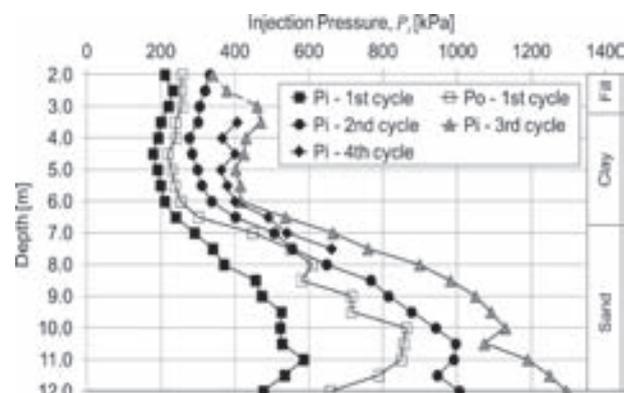
Fig. 12 – Average injection pressures vs. depth, for each cycle, as measured at the manometer [MARCHI *et al.*, 2014].

Figure 12 reports the average steady-state injection pressures (P_i) vs. depth for each cycle, as measured at the manometer. P_i is clearly greater in sand and tends to increase almost linearly with depth. Injection pressures vary between about 200–500
